FAR OUTSIDE THE NORM:
The San Onofre Nuclear Plant's
Steam Generator Problems
in the
Context of the National Experience with
Replacement Steam Generators

by
Daniel Hirsch
and
Dorah Shuey

September 12, 2012

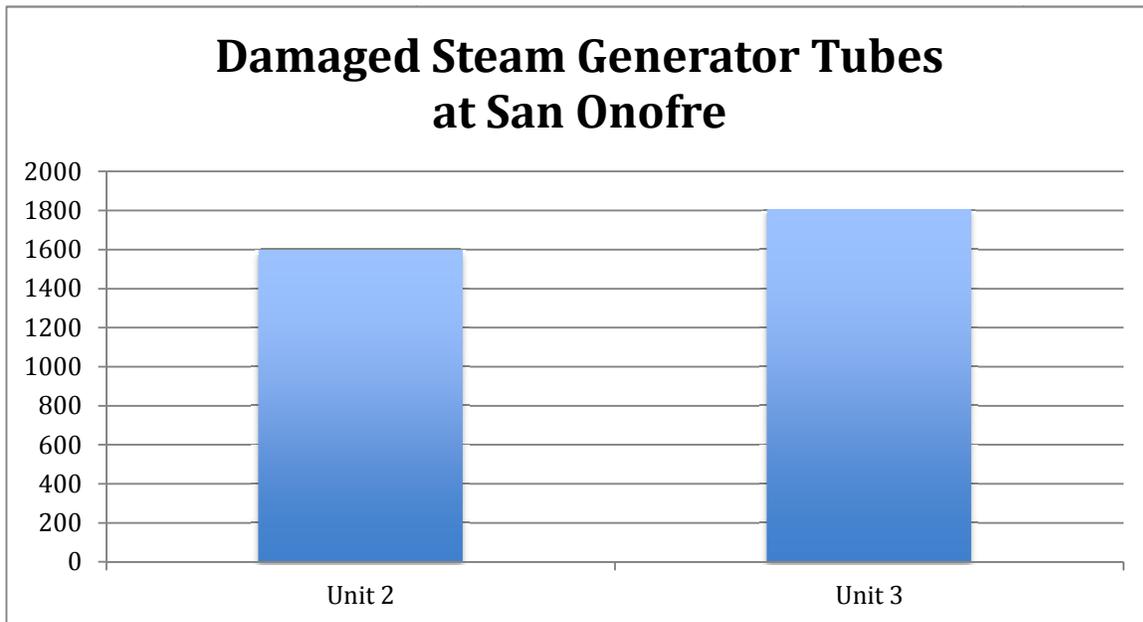
Figure 2

The data tables posted by NRC show similar numbers of damaged tubes in the two units. Unit 2 has 1,595 tubes with wear, Unit 3 has 1,806.

Additionally, as will be seen in Table 3 and Figure 5, the number of steam generator tubes that have had to be plugged in each reactor is in the same approximate range: 510 in Unit 2 and 807 in Unit 3. As this report shows, these numbers are dramatically higher than the national experience. Each San Onofre unit has had to plug many times more tubes than all reactors with new steam generators in the country, over a comparable operational period, combined.

Unit 3 has a somewhat greater number of wear indications than Unit 2 (i.e., tubes showing wear on more than one location per tube) and more tubes in the higher ranges of through-wall wear. And Unit 3 has hundreds of indications of through-wall wear due to tube-to-tube rubbing whereas Unit 2 has only two.

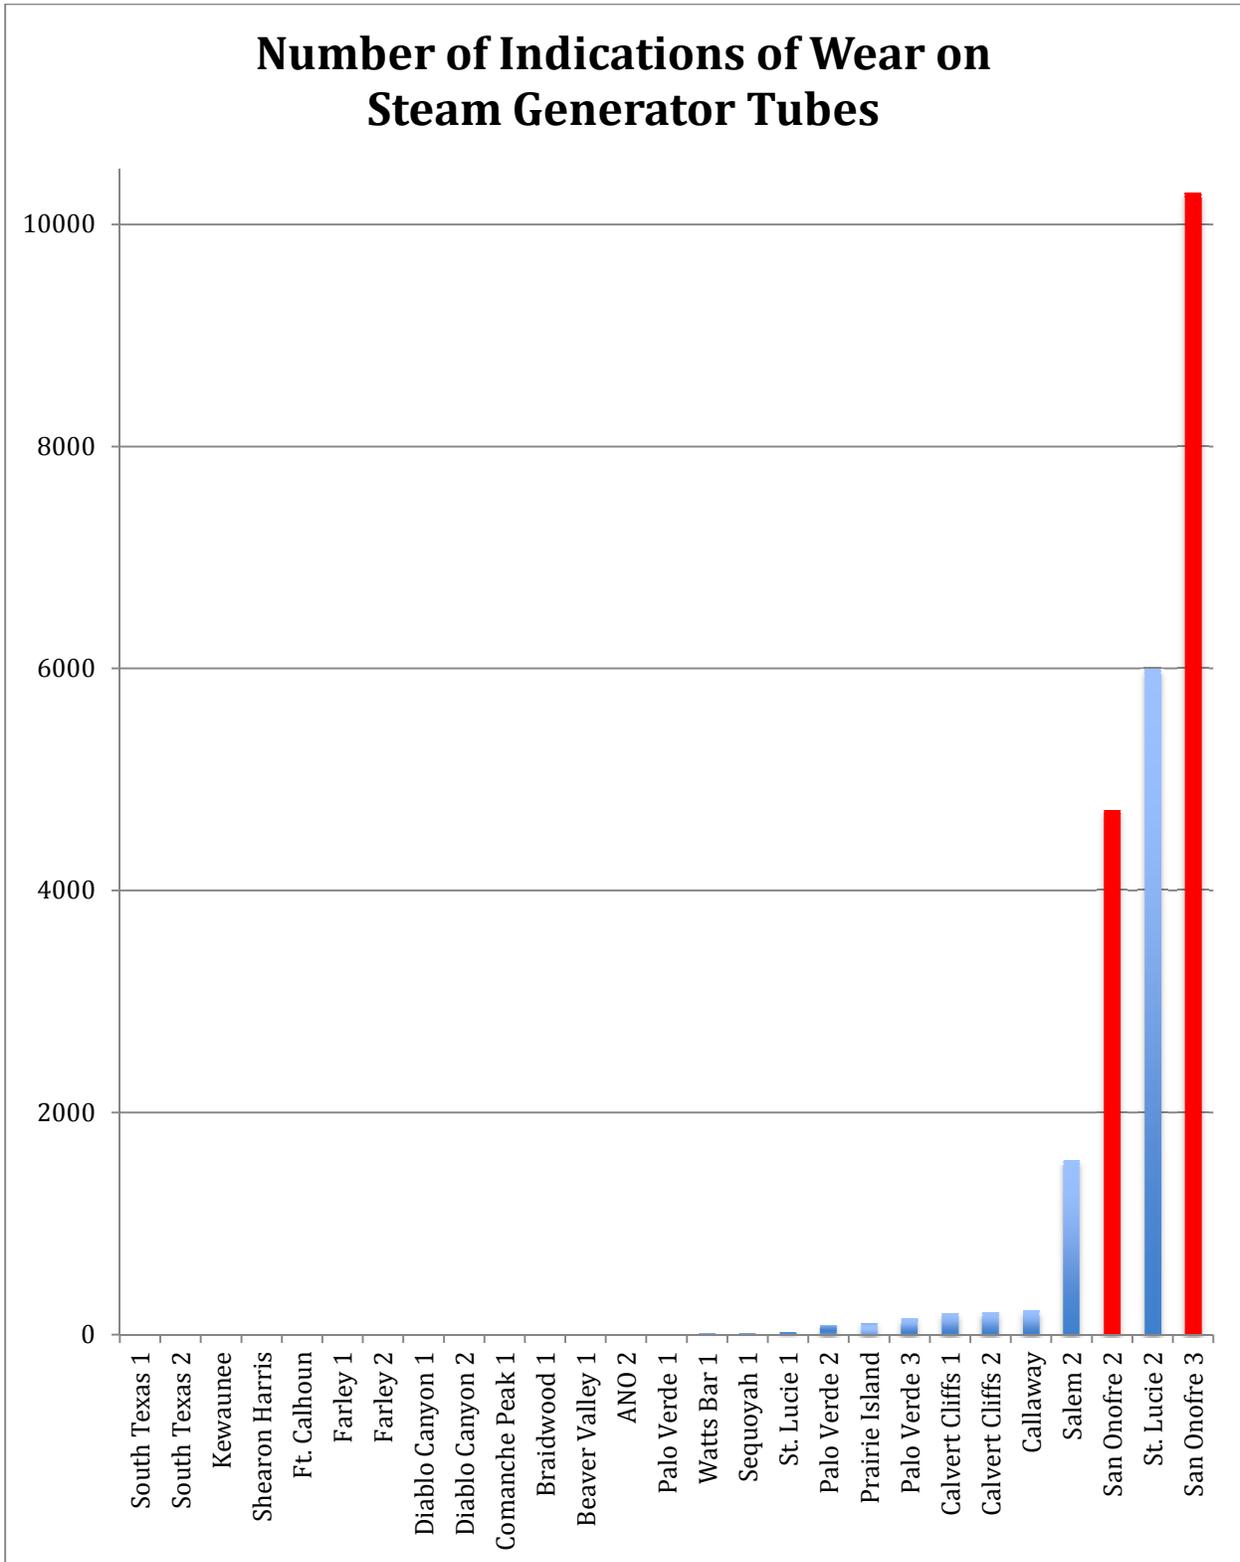
Figure 3

As dramatically shown in Figures 3, 4, and 5 of this report, the San Onofre experience after only two or less years of operation with replacement steam generators lies far outside the bounds of normality when compared to the experience of other nuclear units with such replaced components. Steam generators, and more specifically the tube boundaries, play a critical role in assuring plant safety and the containment of possible radioactive releases. In spite of Edison's attempt to assert a different level of risk between Units 2 and 3, it seems clear that similar design and failure challenges are present in both units and that future operation of either unit has not been technically justified. It is my opinion that measures necessary for the future safe operation of either of these unit have not been adequately put forth at this time, and that operation with or without reduced power of Unit 2 should not be authorized.

- **The median number of steam generator tubes showing wear after one cycle of operation nationally is—FOUR. San Onofre Unit 2 had 1595 damaged tubes, approximately 400 times the median; San Onofre Unit 3 had 1806.**
- **The median number of wear indications on steam generator tubes after one cycle of operation is—FOUR. San Onofre Unit 2 had 4721, greater than a thousand times more. San Onofre Unit 3 had 10,284.**
- **The median number of steam generator tubes that were plugged after one cycle of operation is—ZERO. San Onofre Unit 2 had 510; Unit 3 had 807.^{xxi}**
