**DEMOLITION OF
RADIOACTIVE STRUCTURES
AND THE DISPOSAL AND RECYCLING OF THE DEBRIS
FROM THE SANTA SUSANA FIELD LABORATORY
NUCLEAR AREA
AND THE ROLE PLAYED BY THE
CALIFORNIA DEPARTMENT OF TOXIC SUBSTANCES CONTROL
AND THE CALIFORNIA DEPARTMENT OF PUBLIC HEALTH**

COMMITTEE TO BRIDGE THE GAP

August 5, 2013

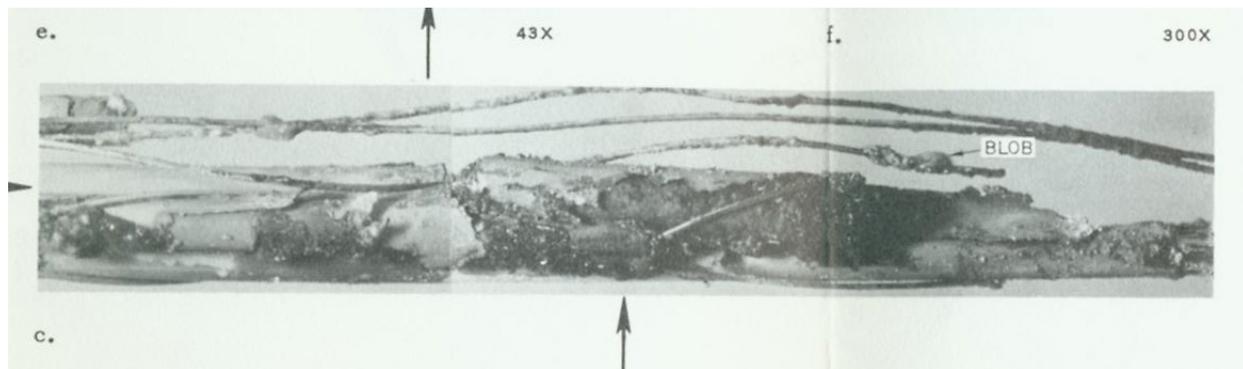
Melted Fuel Rodⁱ from SRE Accident¹¹

ⁱ “blob” label in original government photo

When it was finally shut down, it was determined that thirteen of forty-three fuel elements had experienced melting. The reactor had no containment structure, the concrete dome surrounding modern reactors designed to keep radioactivity from entering the environment. For weeks during and after the accident, radioactivity released from the melted fuel was intentionally vented into the atmosphere. To this day, there remains debate as to how much radioactivity was released, in part because the radiation monitors went off-scale.¹⁰

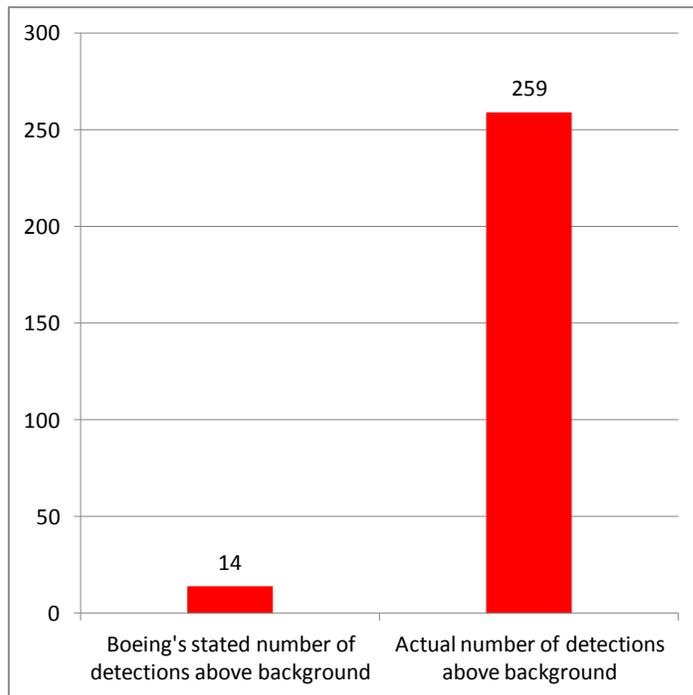
Figure 8: Boeing’s stated number of radiation detections above background levels versus actual number of detections above background in Area IV buildings it has recently demolished⁸⁵

below). Thus, by Boeing’s own measurements, if not consistently by Boeing’s own admission, the buildings are contaminated. Screenshots from Boeing reports showing these scores of detections are shown in Appendix E attached.

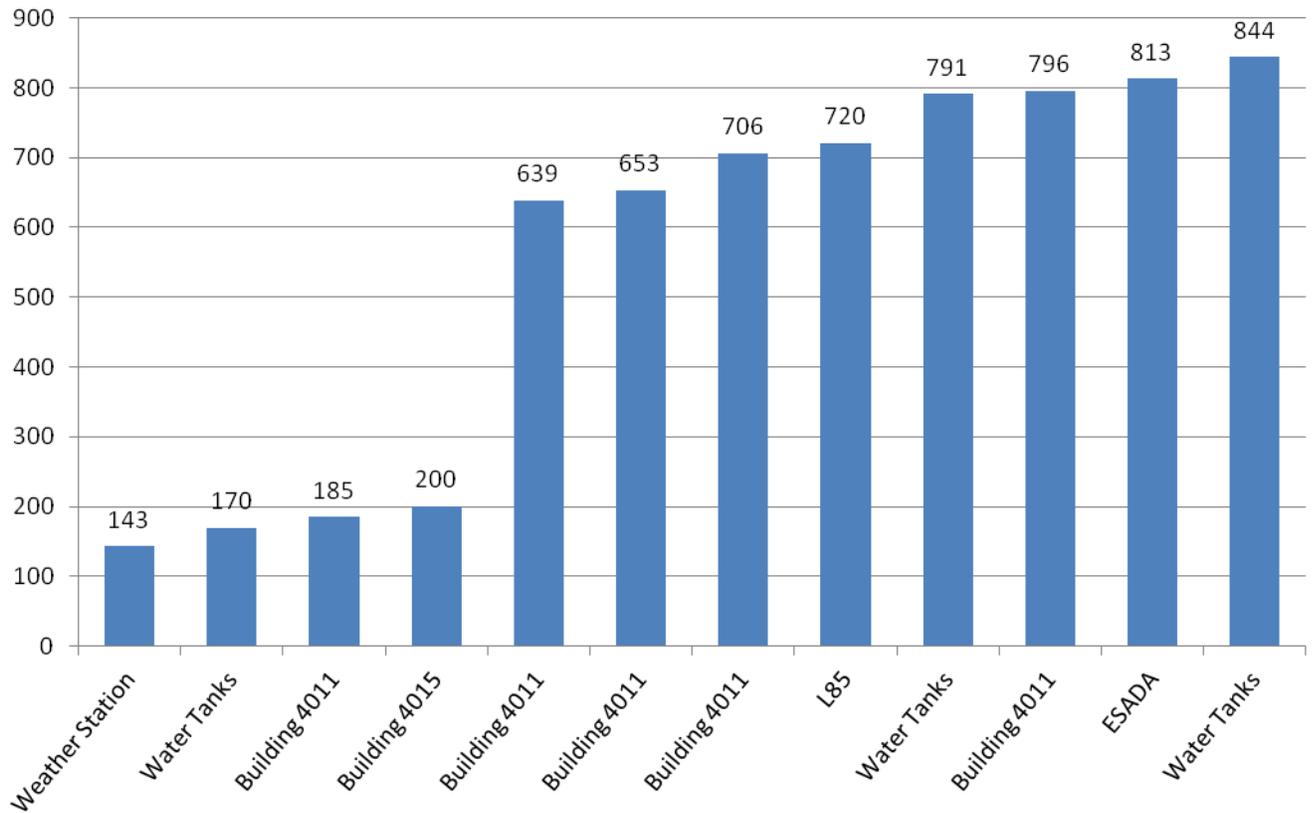
Figure 9: Range of alpha radiation background values used by Boeing to compare with concrete in Boeing Area IV buildings

The background values Boeing uses for concrete in its Area IV buildings vary from a low of **143 dpm/100cm²** to a high of **844 dpm/100cm²**

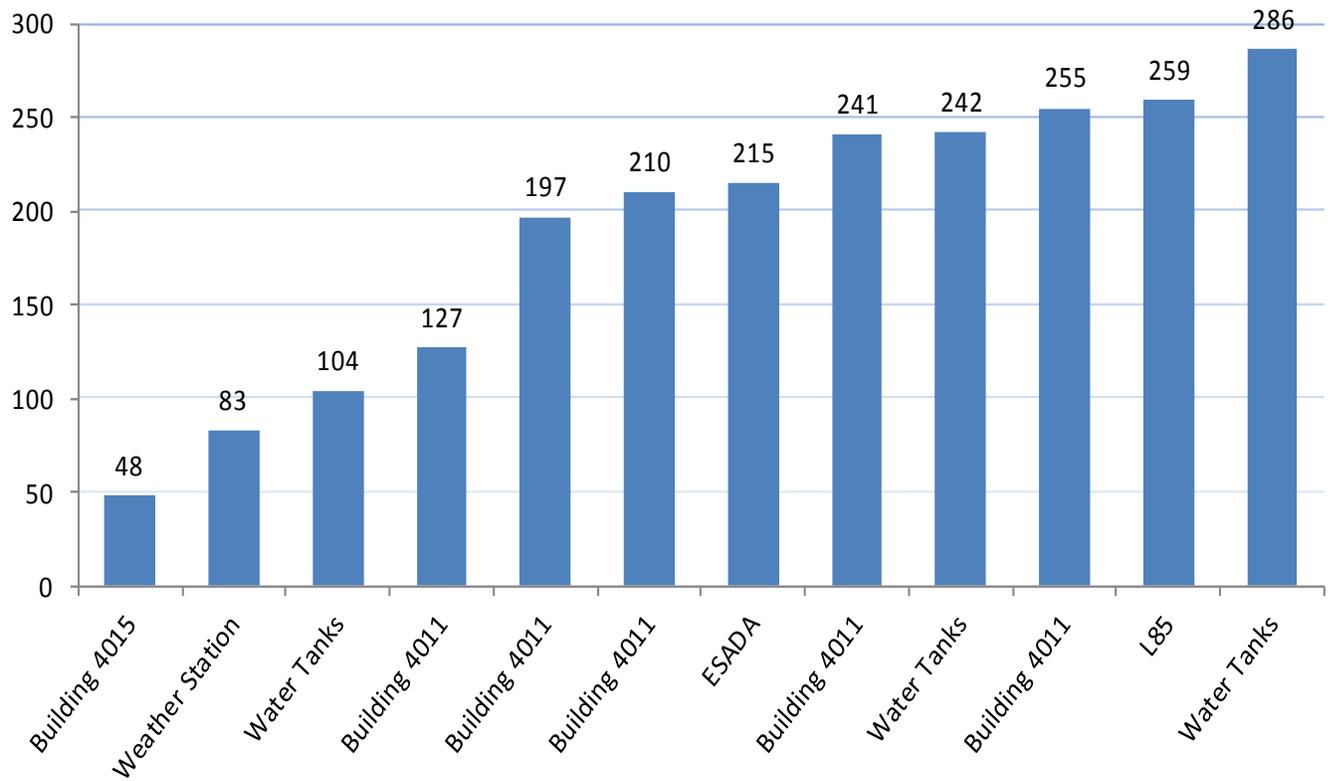
Figure 10: Range of alpha radiation background values used by Boeing to compare with Asphalt in Boeing Area IV buildings

The background values Boeing uses for asphalt in its Area IV buildings vary from a low of 48 **dpm/100cm²** to a high of **286 dpm/100cm²**

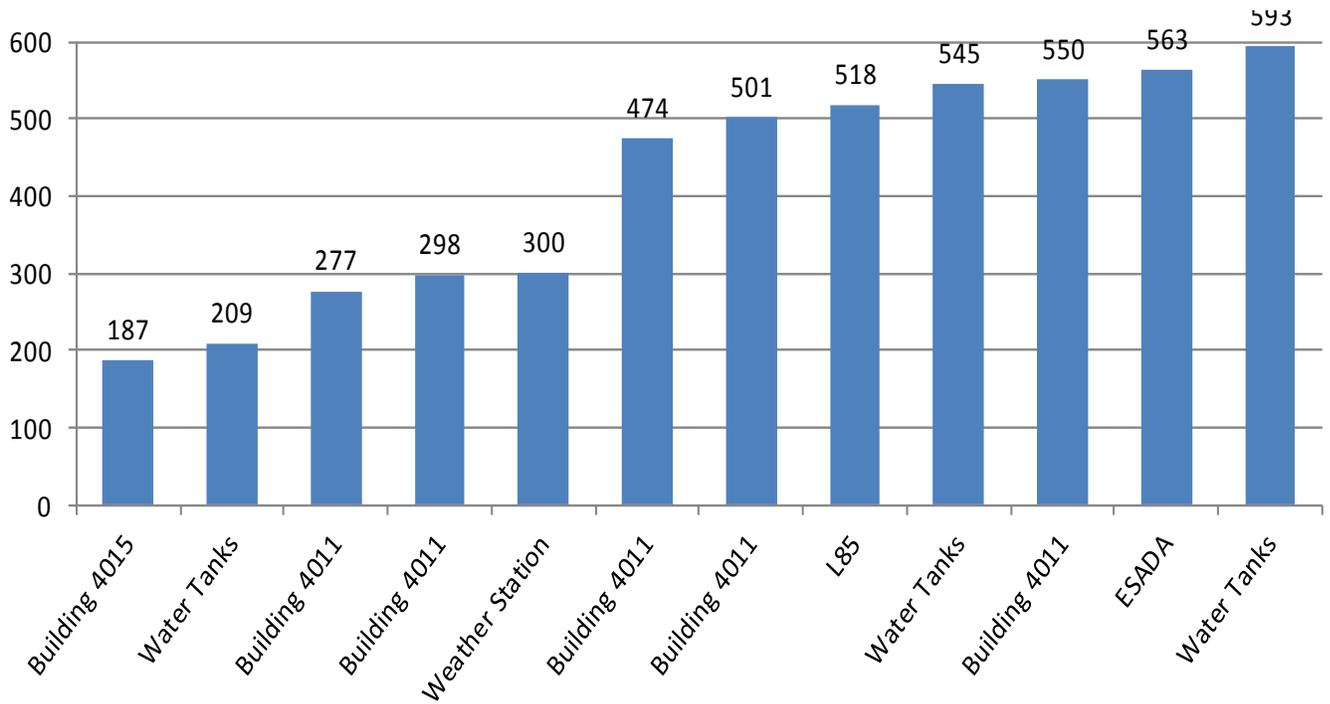
Figure 11: Range of alpha radiation background values used by Boeing to compare with construction materials in Boeing Area IV buildings

The background values Boeing uses for construction materials in its Area IV buildings vary from a low of **187 dpm/100cm²** to a high of **593 dpm/100cm²**.
