FAR OUTSIDE THE NORM:
The San Onofre Nuclear Plant's
Steam Generator Problems
in the
Context of the National Experience with
Replacement Steam Generators

by
Daniel Hirsch
and
Dorah Shuey

September 12, 2012

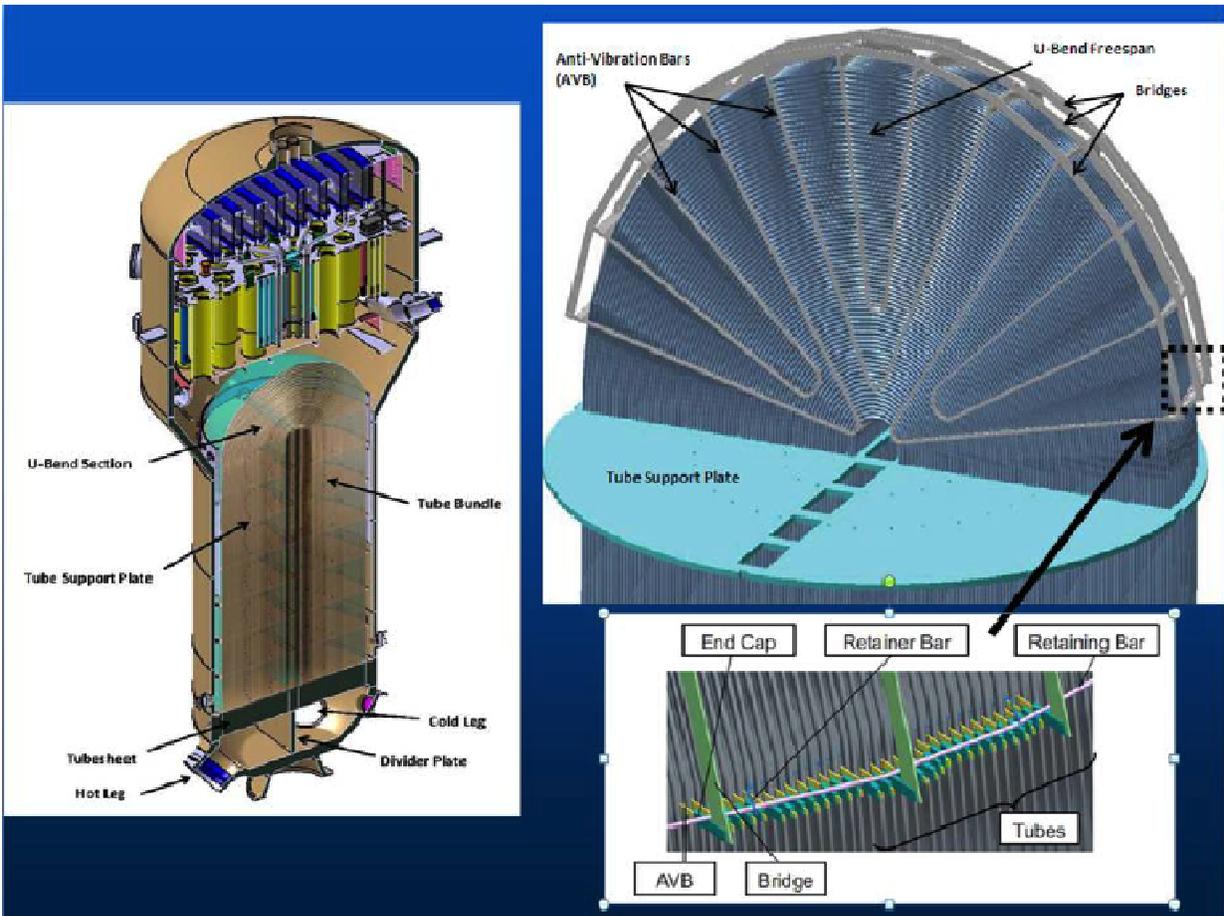
Figure 1 San Onofre Replacement Steam Generator Schematic

The tubes are in an inverted U shape: in the upper part of the steam generator, the tubes bend to return downward again. There are four key parts of the steam generators for the present discussion: the tube support plates, through which the tubes run; the anti-vibration bars (AVBs), designed to reduce vibration; the retainer bars, which help retain the AVBs; and the U-Bend Freespan, where the tubes bend near the top of the steam generator and have no immediate support.

There thus are at least four locations where steam generator tubes can get damaged: they can rub against the tube support plates, the AVBs, the retainer bars, or against each other in the U-Bend Freespan.^{iv} Damage has occurred in the new steam generators at San Onofre at all four locations.
